FATIGUE FAILURE OF ELECTROFORMED PRINTING PLATES

I. J. Feinberg
Engineering Metallurgy Section
Metallurgy Division

Electrolytic Section
Bureau of Engraving and Printing
Washington, D. C.

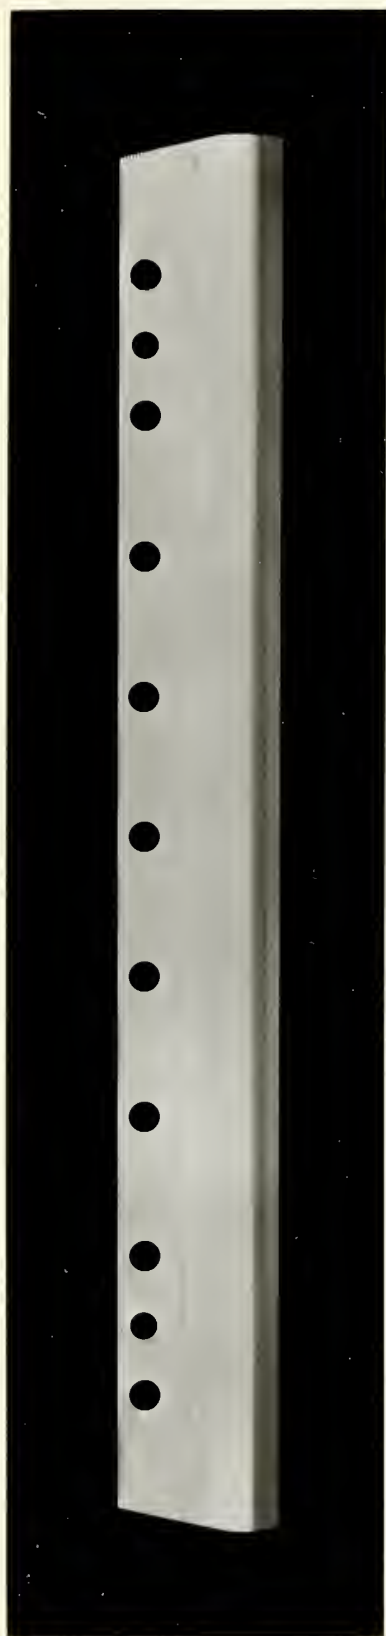
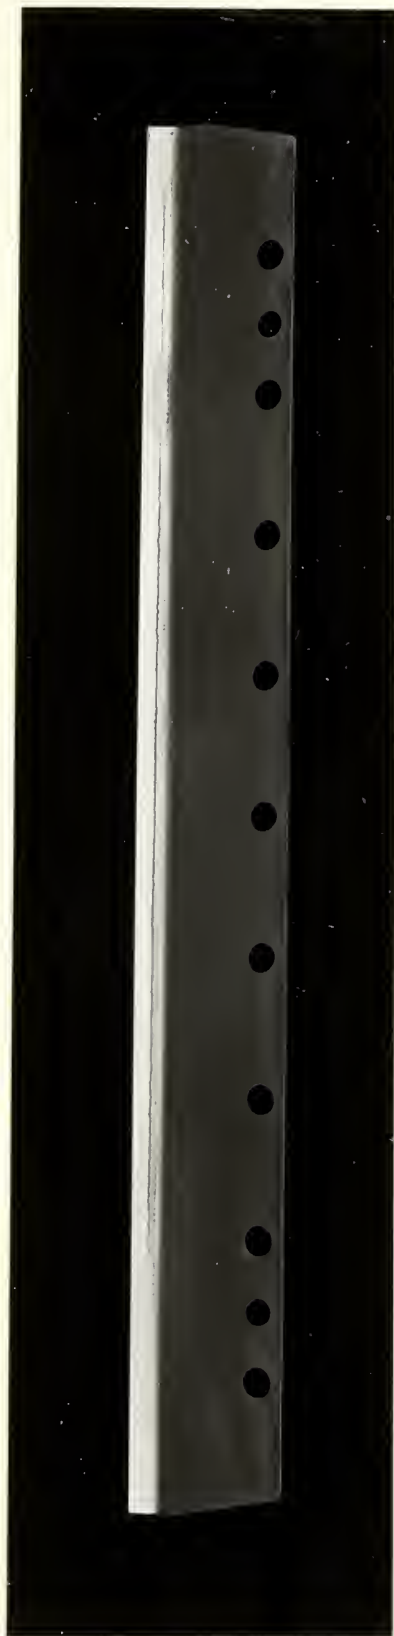
Figure 1. Strip from printing plate No. 40395. The location of the cracks with respect to the plate-bend line is typical of that observed in all of the strips examined.

a. Obverse face. X $1/4$

b. Reverse face. X $1/4$

All of the strips contained cracks that were adjacent to and parallel to the bend line in plate Vee bends - bends necessary for adaptation of the plates to the press cylinder. The cracks observed varied in length from approximately one inch in one plate to three-fourths of the plate width in others. A typical view of the general location of the cracks with respect to the plate bend line is shown in Figure 1. Strip identifications and pertinent plating and service life data are given in Table 1. The Bureau of Engraving and Printing (BE&P) requested NBS to determine whether cracking could be attributed to detrimental material conditions or to mechanical factors. BE&P also requested that the mechanical properties of the materials be established for their records and possible future reference.

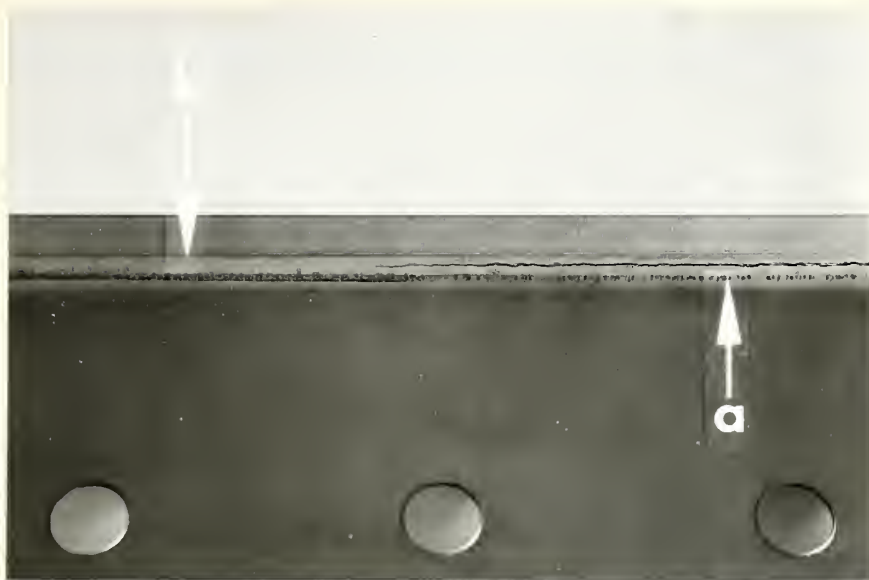
Figure 2a. Reverse face of a section of strip No. 40418 L. Arrow, a, points to fretting in the bend line. Arrow, b, points to a continuous line that resulted from a polishing action. Note that the fracture path is between these lines. X 2/3

Macroscopic Examination: Figure 2a is a view of the reverse face of a plate section containing a fracture. It shows fretting in the bend line, arrow a, and a continuous line resulting from a polishing action, arrow b. The fracture path is between these lines. Figure 2b is a view of the fracture surface of the section shown in Figure 2a. It has the characteristic features of a fracture surface resulting from fatigue. Its appearance is typical of that observed in all of the fractured plates.

Discussion and Conclusions: Failure of the subject plates is attributed to fatigue. It appears that cracks could have been initiated in the chromium plating adjacent to plate bend lines when the bends were formed. These cracks created notches that acted as stress raisers. The presence of polishing and fretting on the printing plates indicates that there was relative motion between plates and press cylinder during press operation. This motion was attended by cyclic bending stresses of such magnitude as to favor the propagation of fatigue cracks starting from the root of the cracks in the chromium plating and progressing through the nickel base.

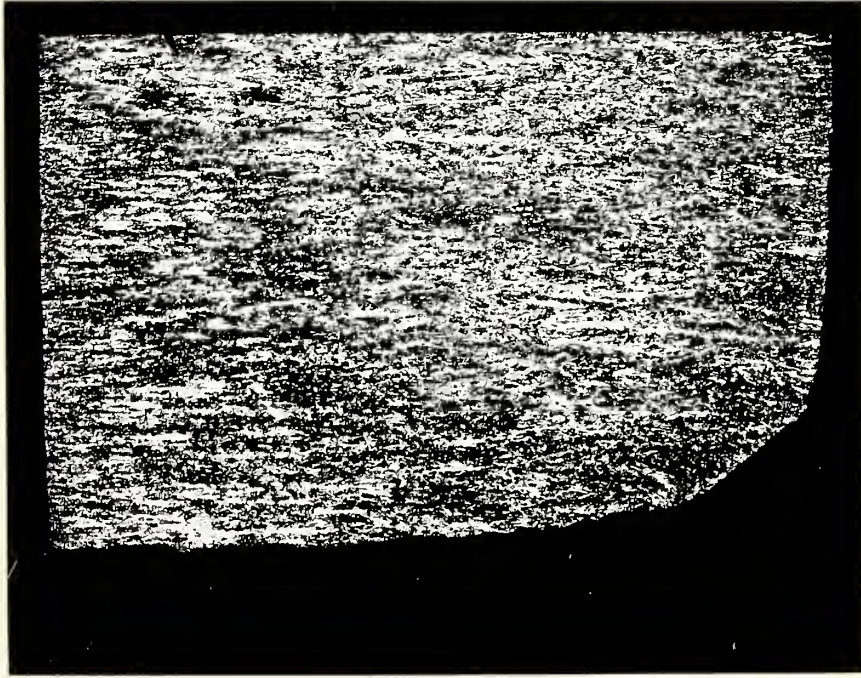
Figure 3. Microstructures and fracture profiles representative of two plates. Fractures were initiated at the obverse (printing) face (at the upper left hand corner in both photomicrographs). Etched with Carapella's reagent. X 100

a. Plate 40400 produced in Watts bath.

Microscopic Examination: Figures 3a and 3b show the microstructure and fracture profiles of low mileage plate, 40400, and high mileage plate, 40364, respectively. The fine-grained microstructure, Figure 3a, is characteristic of that obtained in a Watts bath and the coarse grained structure, Figure 3b, is characteristic of that obtained in a sulfamate bath. The fracture path shown in Figure 3a is predominantly flat and intergranular while in Figure 3b, it is predominantly transgranular.

Both fractures were initiated by fatigue cracks originating at the obverse (printing) face of the plates. The flat profile of the fracture in Figure 3a is characteristic of material that failed rapidly and in a brittle manner. The fracture of plate 40364, Figure 3b, was accompanied by plastic deformation. The uneven fracture profile is characteristic of a fracture that propagated through shear. Shear fractures are peculiar to material having good ductility.

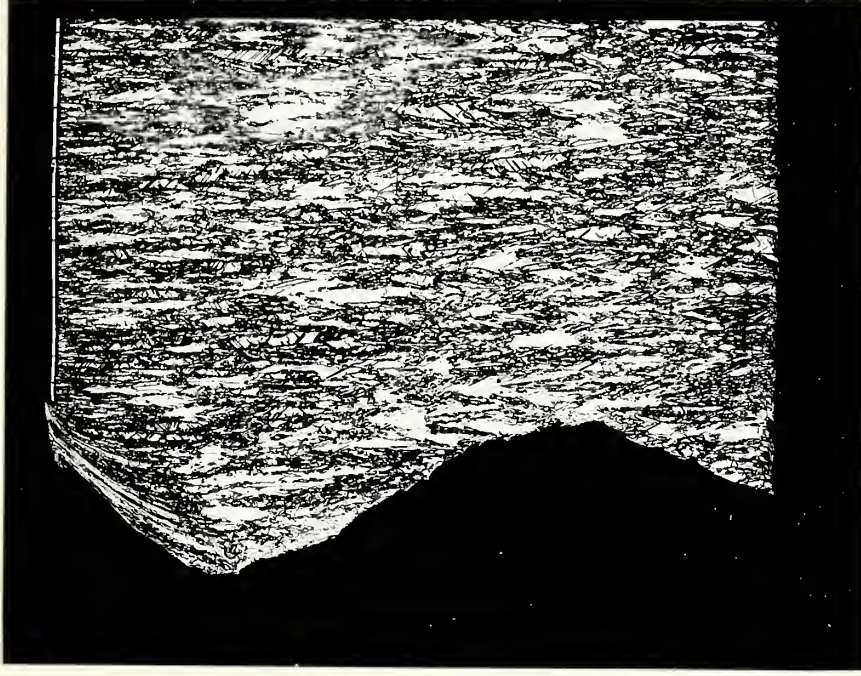
b. Plate 40364 produced in sulfamate bath.

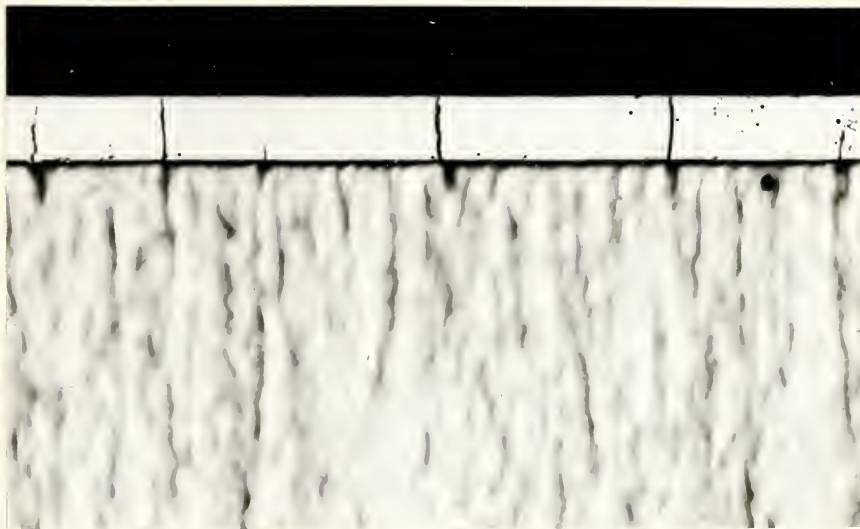
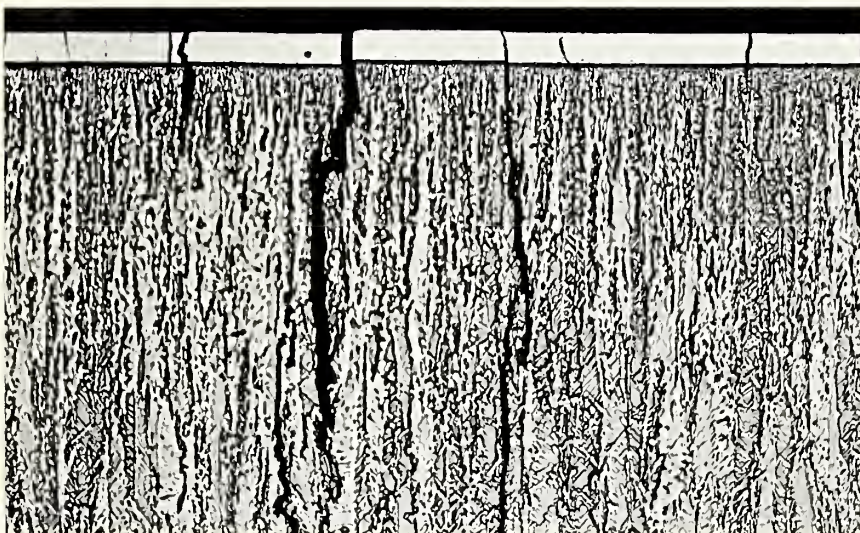
Figure 4. Typical secondary cracks adjacent to a fracture.

- a. Cracks in the chromium plate (white) appear to have been initiated at the interface of the plate and nickel base. Etched with Carapella's reagent. X 1000
- b. Cracks in the chromium plate have propagated to the plating surface and into the nickel base. Etched with Carapella's reagent. X 500

The photomicrographs of secondary cracks in Figure 4 provide a clue as to the mechanism of crack propagation in the subject plates. Figure 4a shows cracks originating at and propagating from the chromium plate-nickel base interface; some of the cracks having propagated to the plating surface and to a lesser degree into the base metal. When the cracks had penetrated the plating completely, notches were created that acted as stress raisers promoting deep penetration of fatigue cracks into the base metal as shown in Figure 4b.
